Service Repair Documentation Level 3 (basic) – SL75

Technical Documentation
TD_Repair_L2.5L_SL75_R1.1.pdf

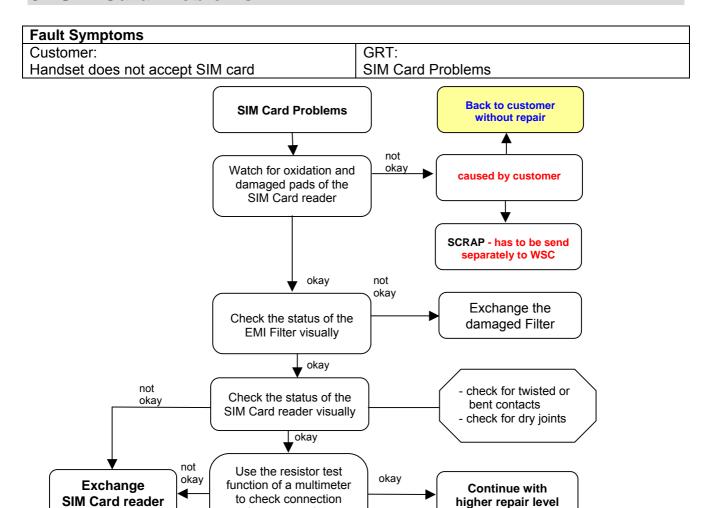
Connector SIM Card Reader

IRIS Diagnose Code: 43300 Interface/SIM Card reader/Mechanical Damage

Use soldering iron to remove defective component. Avoid excessive heat! Watch surrounding components! Resolder new component afterwards.

E-commerce order number: L50634-Z97-C406

E-commerce order name: CONNECTOR SIM CARD READER R65 (B)

between spring contacts and soldering contacts. The value must be $\sim 0\Omega$

Soldering temperature: ~ 360°C TIP Temp.

EMI Filter

Use hot air blower to remove defective component. Avoid excessive heat! Watch surrounding components! Resolder new component afterwards.

E-commerce order number: L50620-U6029-D670

E-commerce order name: FILTER EMI (Fi-Type7) PB Free

Soldering temperature: ~ 360°C TIP Temp

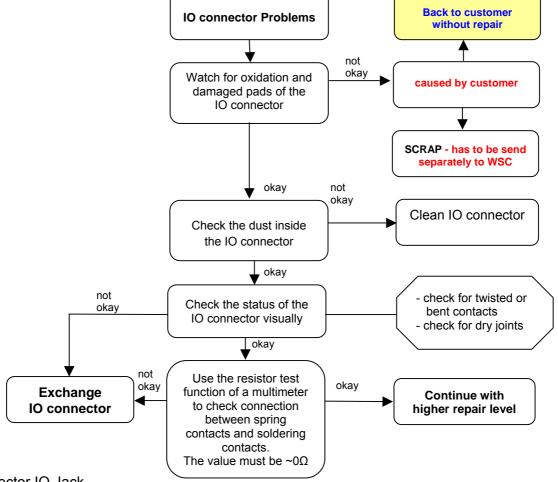
Connector IO Jack

Customer: Charging Problems Problems with external loudspeaker or microphone when using a car kit Problems with accessories connected at the IO connector

IRIS Diagnose Code: 46100 Interface/Charging Connector/Mechanical Damage

47300 Interface/Data Interface/Mechanical Damage 4B100 Interface/Headset Connector/Mechanical Damage

Use soldering iron to remove defective component. Avoid excessive heat! Watch surrounding components! Resolder new component afterwards.

E-commerce order number: L36334-Z93-C303 E-commerce order name: IO-JACK SLIM 12-POL Soldering temperature: ~ 360°C TIP Temp.

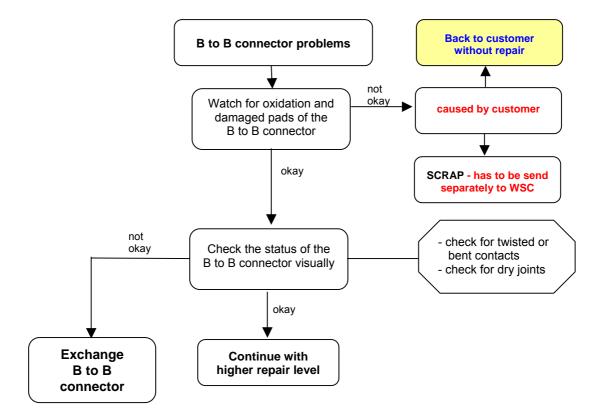
Connector Board to Board

Fault SymptomsCustomer:GRT:Upper slider keyboard malfunctionKeyboard malfunctionUpper slider keypad illumination does not workCurrent measured failedDisplay problemsCurrent measured failed

IRIS Diagnose Code: 32100 Keys / Main / No Function

32200 Keys / Main / Reduced Functionality

36000 Keys / Illumination

Use hot air blower to remove defective component. Avoid excessive heat! Watch surrounding components! Resolder new component afterwards.

E-commerce order number: L50634-Z97-C340

E-commerce order name: BOARD TO BOARD 30-POL

Soldering temperature: ~ 360°C TIP Temp.

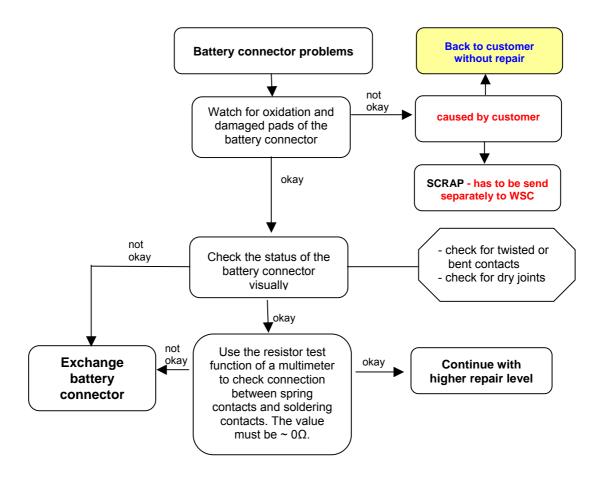
Connector BATTERY

Fault Symptoms		
Customer:	GRT:	
Mobile does not switch on	No connection to GRT

IRIS Diagnose Code: 13000 Battery/Mechanical Damage

Use hot air blower to remove defective component. Avoid excessive heat! Watch surrounding components! Resolder new component afterwards.

E-commerce order number: L36334-Z97-C213

E-commerce order name: CONNECTOR BATTERY 3-POL

Soldering temperature: ~ 360°C TIP Temp.

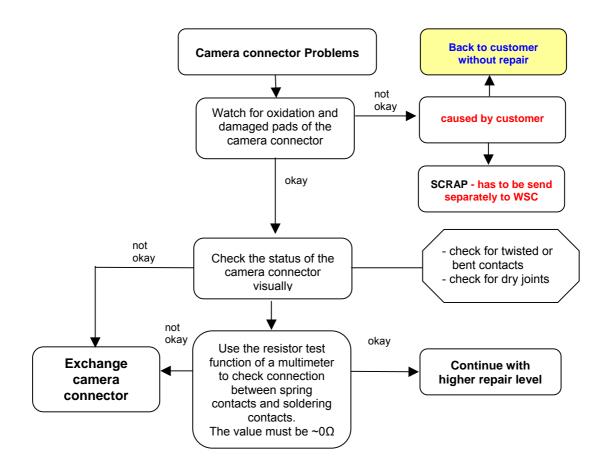
Connector CAMERA

Fault Symptoms		
Customer:	GRT:	
Camera malfunction	Tbd.

IRIS Diagnose Code: BA000 Accessories / Camera

Use hot air blower to remove defective component. Avoid excessive heat! Watch surrounding components! Resolder new component afterwards.

E-commerce order number: L50634-Z97-C379

E-commerce order name: CONNECTOR CAMERA-SOCKET

Soldering temperature: ~ 360°C TIP Temp.

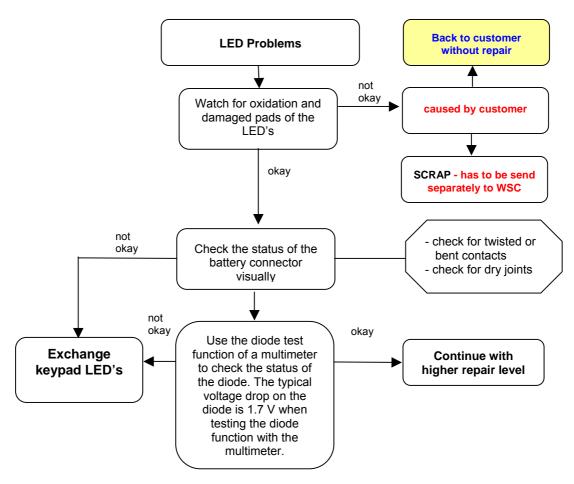
Fault Symptoms	
Customer:	GRT:
Main keypad illumination does not work	Current measured failed

IRIS Diagnose Code: 36000 Keys/Illumination

Use soldering iron to remove defective component. Avoid excessive heat! Watch surrounding components! Resolder new component afterwards.

Attention: Remove Metal Dome Sheet before!!!

E-commerce order number: L36840-L2099-D670 E-commerce order name: LED WHITE TOP Soldering temperature: ~ 360°C TIP Temp.
