# Level 2.5 Repair Documentation for XELIBRI

## X2 & X4

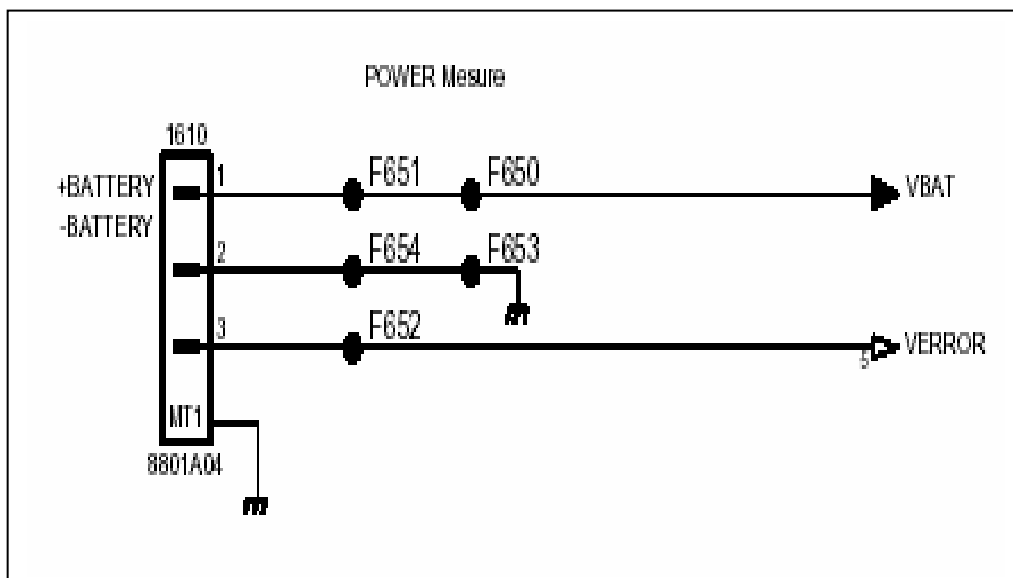
Can't power on under normal operation  
Can't charge this handset when power off

The connector (1610) is the battery connector with 3 contacts.  
During power on, 3.5V to 4.2V is supplied to the handset via VBat.  
VERROR is provided to the Battery, goes into the Power Management Unit control charge.

1. Use a hot air nozzle to remove the defective connector.  
***Do not apply excessive heat and flow to avoid to destroy the adjoining solder joints.***
2. Level the solder joint on the pads (eventually add solder).
3. Secure new connector on the PCBA.
4. Reheat the solder on the pads with a fine-tipped soldering iron to allow the solder to flow on the connector's pins.

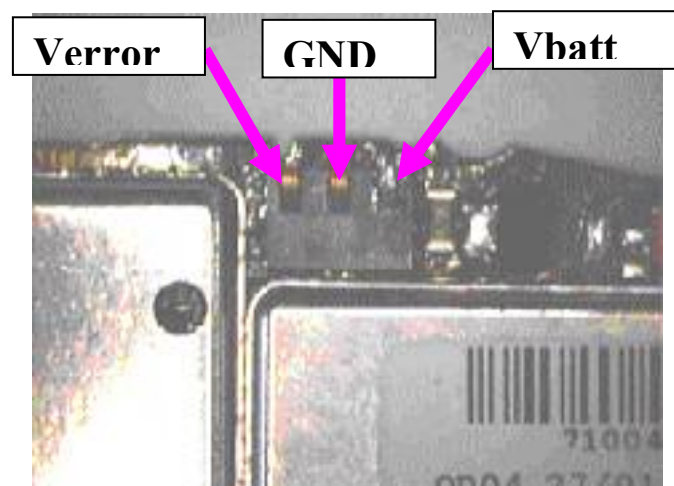
**Figure 1: XELIBRI Board Battery Connector Placement**

Visually check pins for oxidation or deformity.  
Measure pins to test points (Vbat, GND, Verror) with a multimeter to check for continuity.

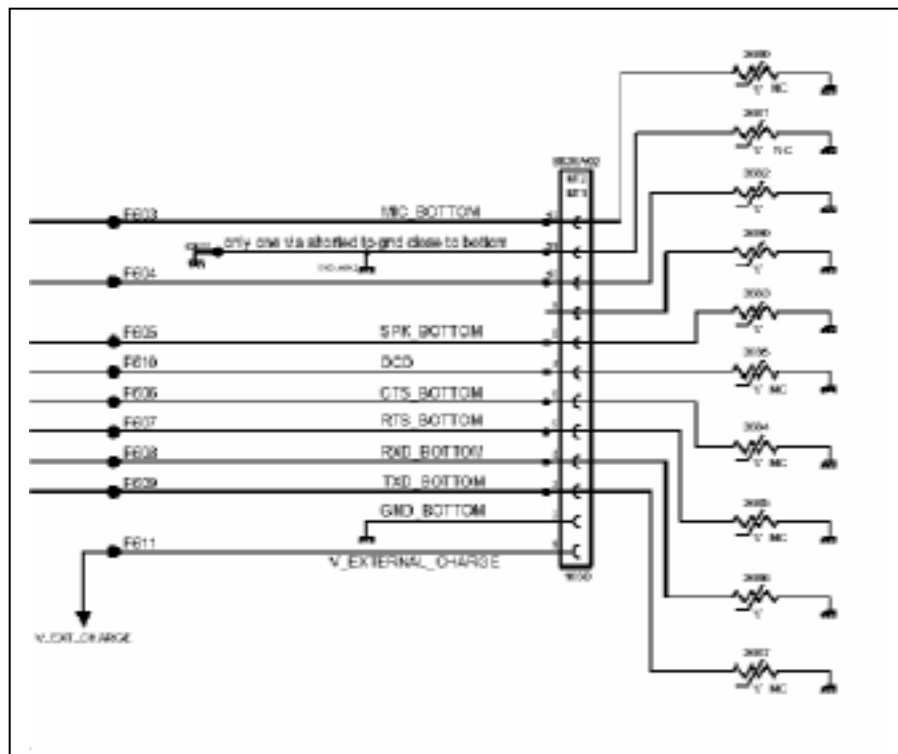
Can not charge the handset

The connector (1660) is I/O connector (12 contacts) used the adapter charger.  
The adapter charger uses the PIN1 for V\_EXTERNAL \_Charge and PIN2 GND  
BOTTOM

1. Use a hot air nozzle to remove the defective connector.  
***Do not apply excessive heat and flow to avoid to destroy the adjoining solder joints.***
2. Level the solder joint on the pads (eventually add solder).
3. Secure new connector on the PCBA.
4. Reheat the solder on the pads with a fine-tipped soldering iron to allow the solder to flow on th the connector's pins.

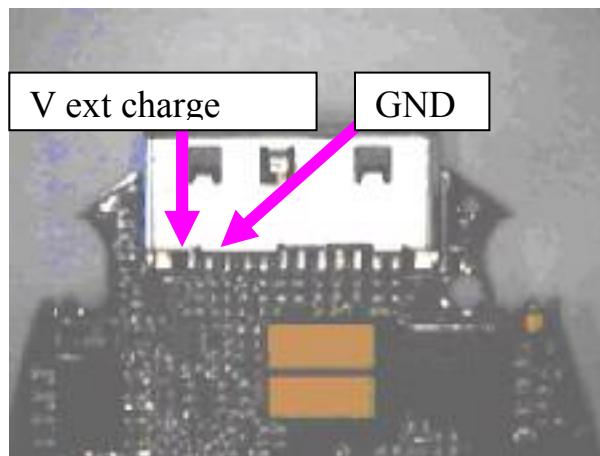
**Figure 2: XELIBRI Board Battery Connector Placement**

Visually check pins for oxidation or deformity.

Visual inspection of the fittings and I/O pads solder joints (short circuit, leak, poor brightness).
