A60/C60/C61

Level 2.5

Repair Documentation

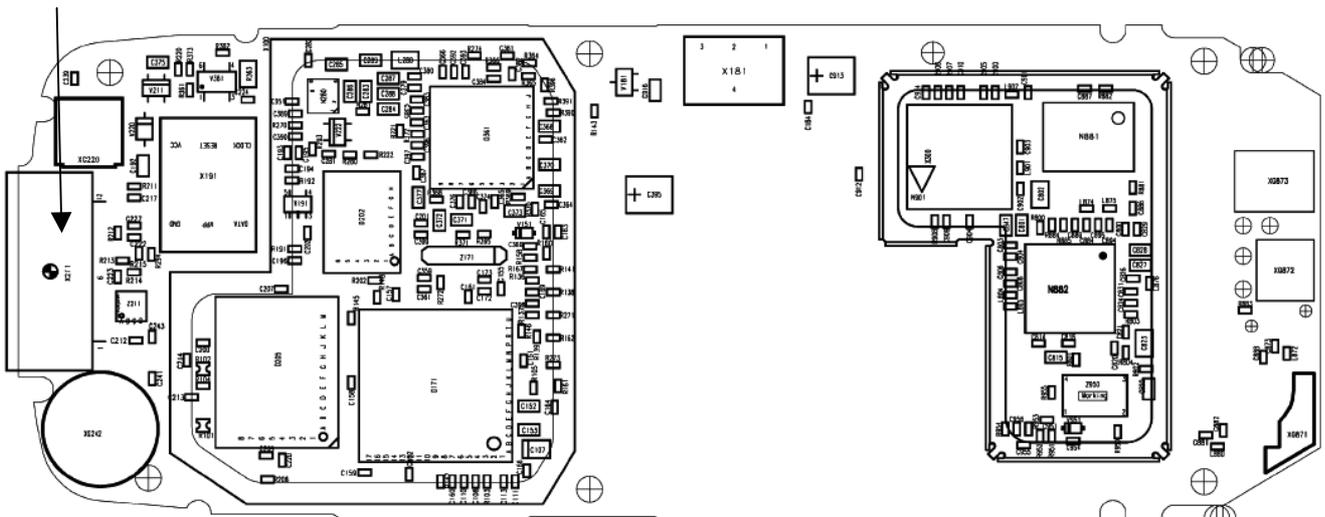
Visually check the bottom connector. Watch for dry joints:

Figure 1: C60/C61 board I/O connector

Use hot air blower remove defective I/O connector.
Avoid excessive heat!
Watch surrounding components!

Resolder new I/O connector afterwards.

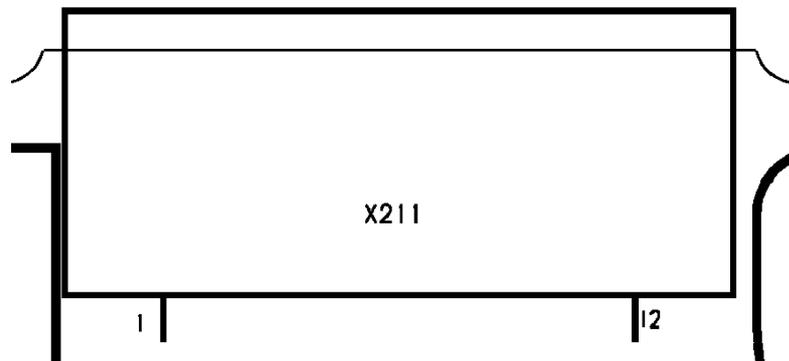
Figure 2: C60/C61 I/O connector placement (top view)

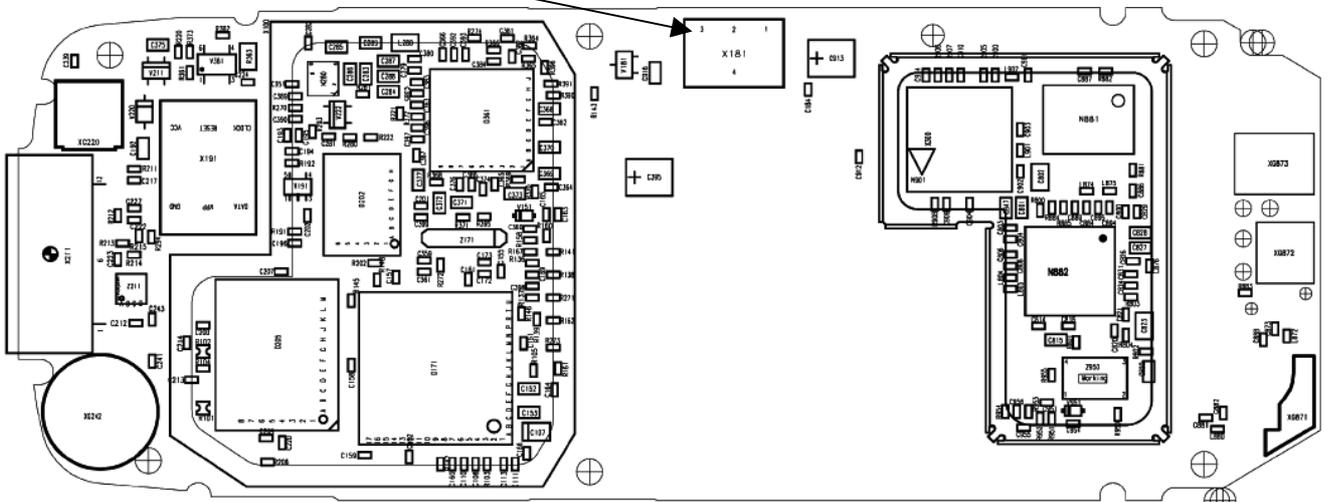
Visually check the status of the Battery connector. Watch for oxidation and dry solder joints.

Figure 1: C60/C61 board Battery connector

Use hot air blower remove defective Battery connector.
Avoid excessive heat!
Watch surrounding components!

Resolder new Battery connector afterwards.

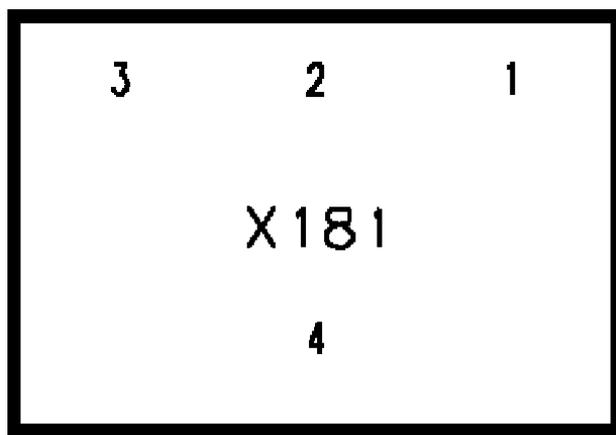
Figure 2: C60/C61 Battery connector placement (top view)

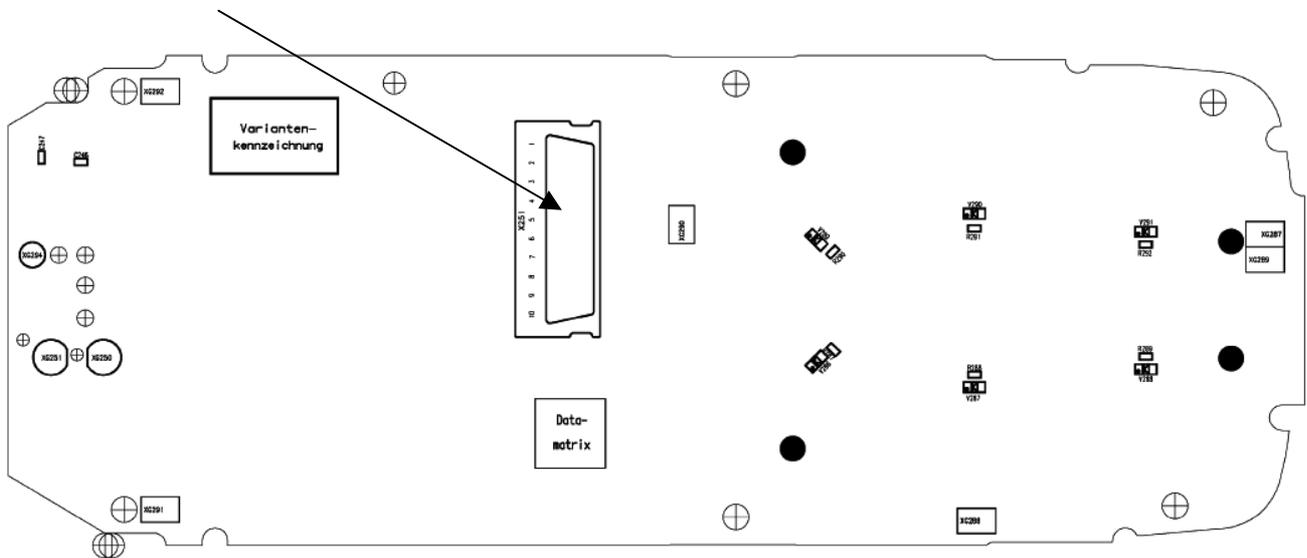
Visually check the status of the Display connector. Watch for oxidation

Figure 1: C60/C61 board Display connector

Use hot air blower remove defective Display connector.

Resolder new Display connector afterwards.

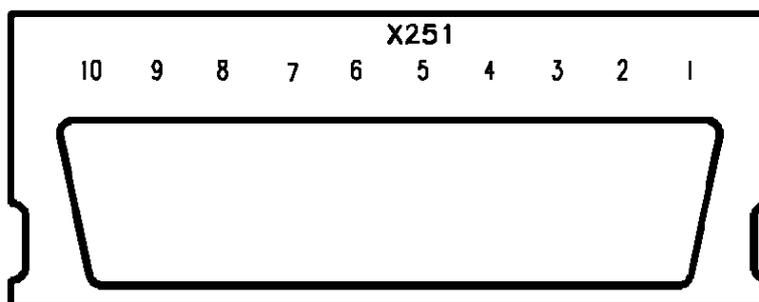
Figure 2: C60/C61 Display connector placement (top view)

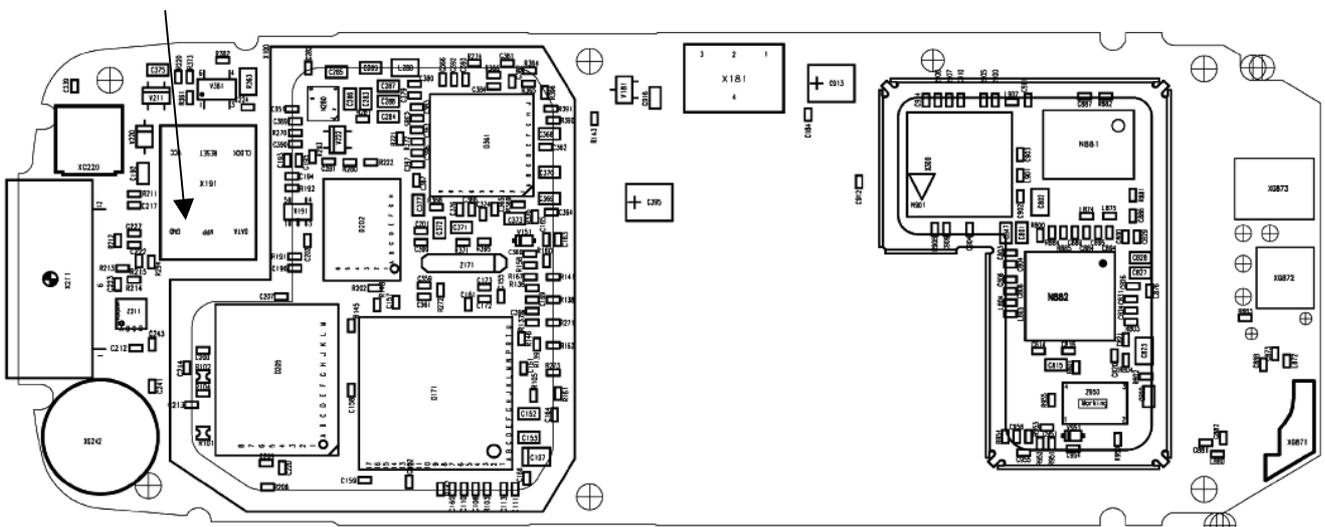
Visually check the Card Reader. Watch for dry joints:

Figure 1: C60/C61 board Card Reader site

Use soldering iron to remove defective component.
Avoid excessive heat!
Watch surrounding components!

Resolder new Card Reader afterwards.

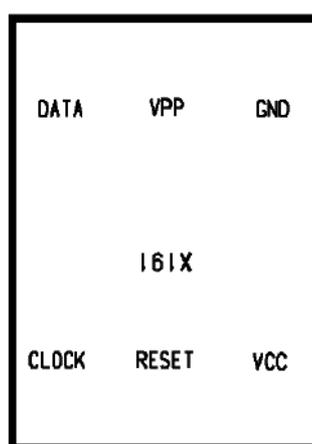
Figure 2: C60/C61 Card Reader placement (top view)

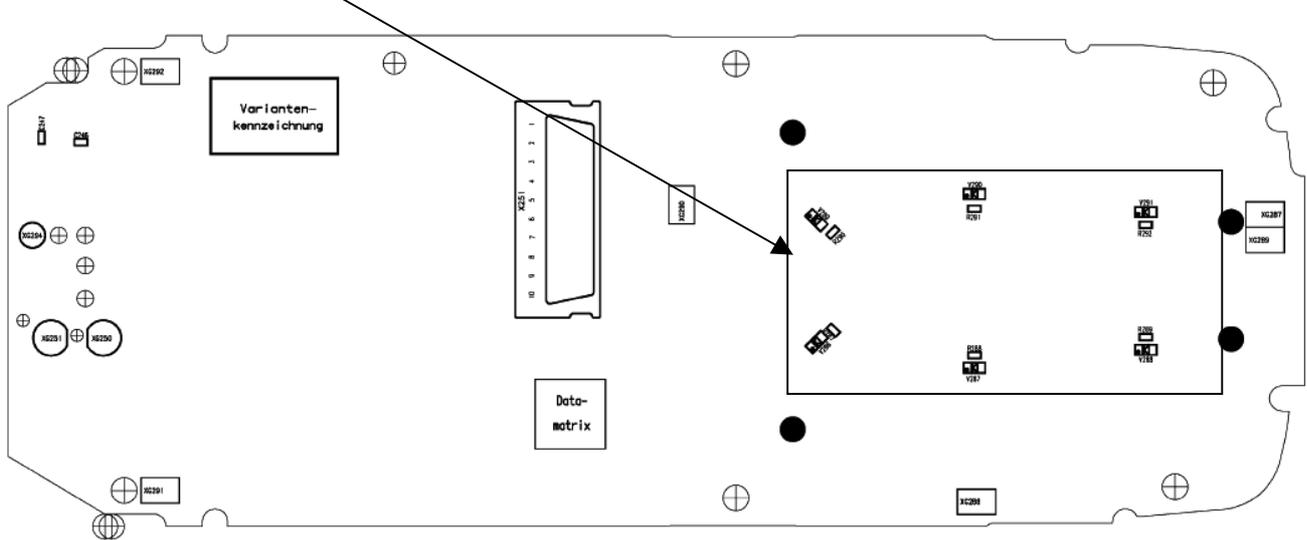
Use the diode test function of a multimeter to check the status of the diode. The typical voltage drop on the diode is 1.7 V when testing the diode function with the multimeter.

Figure 1: C60/C61 Keypad LEDs side

Use soldering iron to remove defective diode.
Avoid excessive heat!
Watch surrounding components!!

Resolder new connector afterwards.

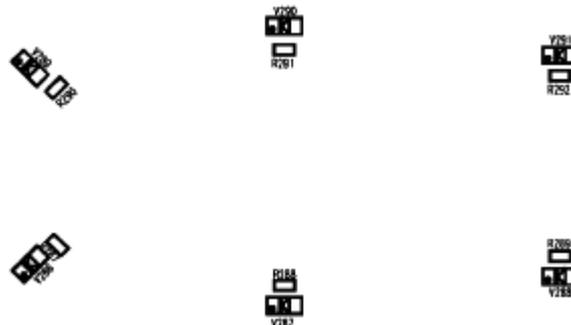
Figure 2: C60/C61 Keypad LEDs placement (top view)
