# Xelibri 5, Xelibri 6 and Xelibri 7

## Level 2.5

### Repair Documentation

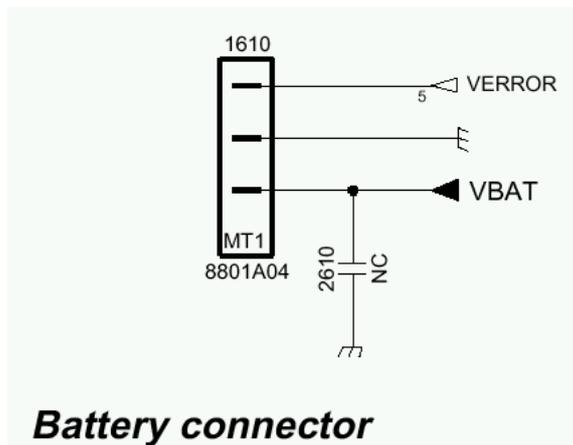
The connector (1610) is a battery connector with 3 contacts. During power on, 3.5 V to 4.2V is supplied to the handset via V Bat. VERROR is provided to the Battery, go into the Power Management Unit control charge.

Use a hot air nozzle to remove the defective connector. *Do not apply an excessive heat and flow to avoid destroying the adjoining solder joints.* Level the solder joint on the pads (eventually add solder). Secure new connector on the PCBA. Reheat the solder on the pads with a fine-tipped soldering iron to allow the solder to flow on the connector's pins.

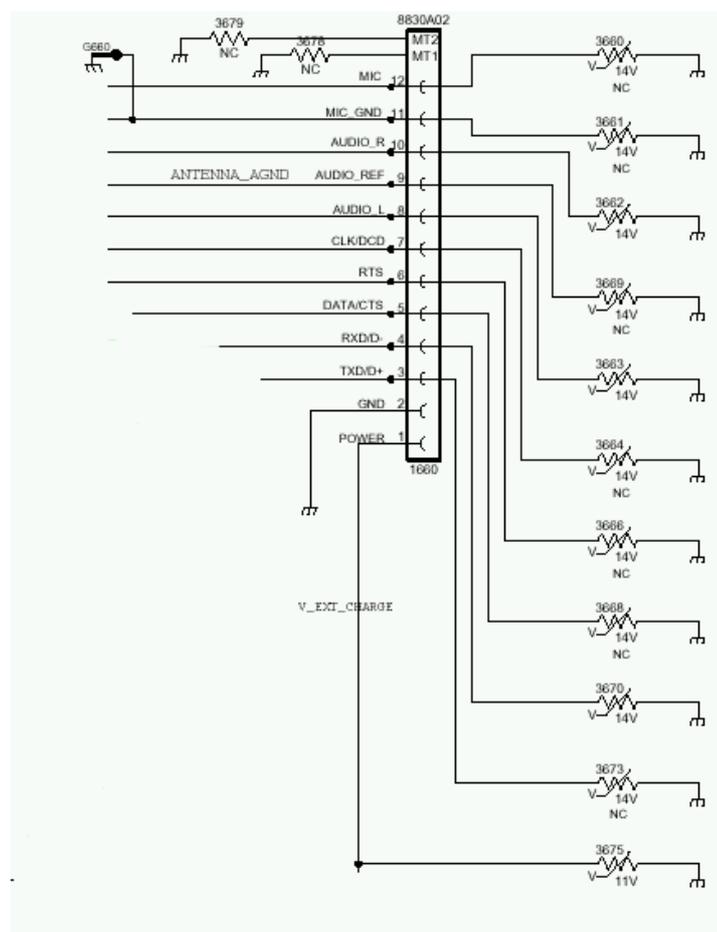
The connector (1660) is I/O connector (12 contacts) used the adapter charger.

The adapter charger uses the pin1 for V\_EXTERNAL\_Charge and PIN 2 GND BOTTOM

Visually check pins for oxidation or deformity. Visual inspection of the fittings and I/O pads solder joints (short circuit, leak, poor brightness). Measure pins (diode zener pos 6640) to pins (Vexternal charge, GND) with a multimeter to check for continuity

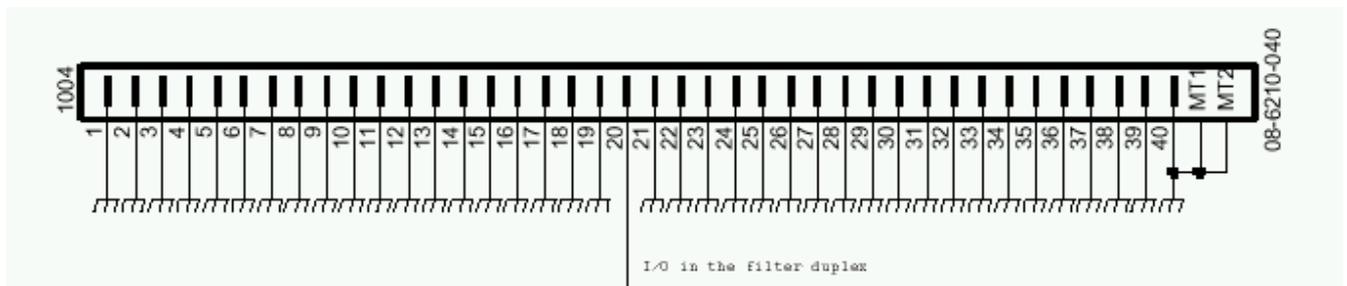
The connector (1004) is connected (40 contacts) used for Flex antenna. All the pins are ground except the pin 20

Visually check pins for oxidation or deformity. Visual inspection of the fittings and I/O pads solder joints (short circuit, leak, poor brightness). Measure pins to test points with a multimeter to check for continuity

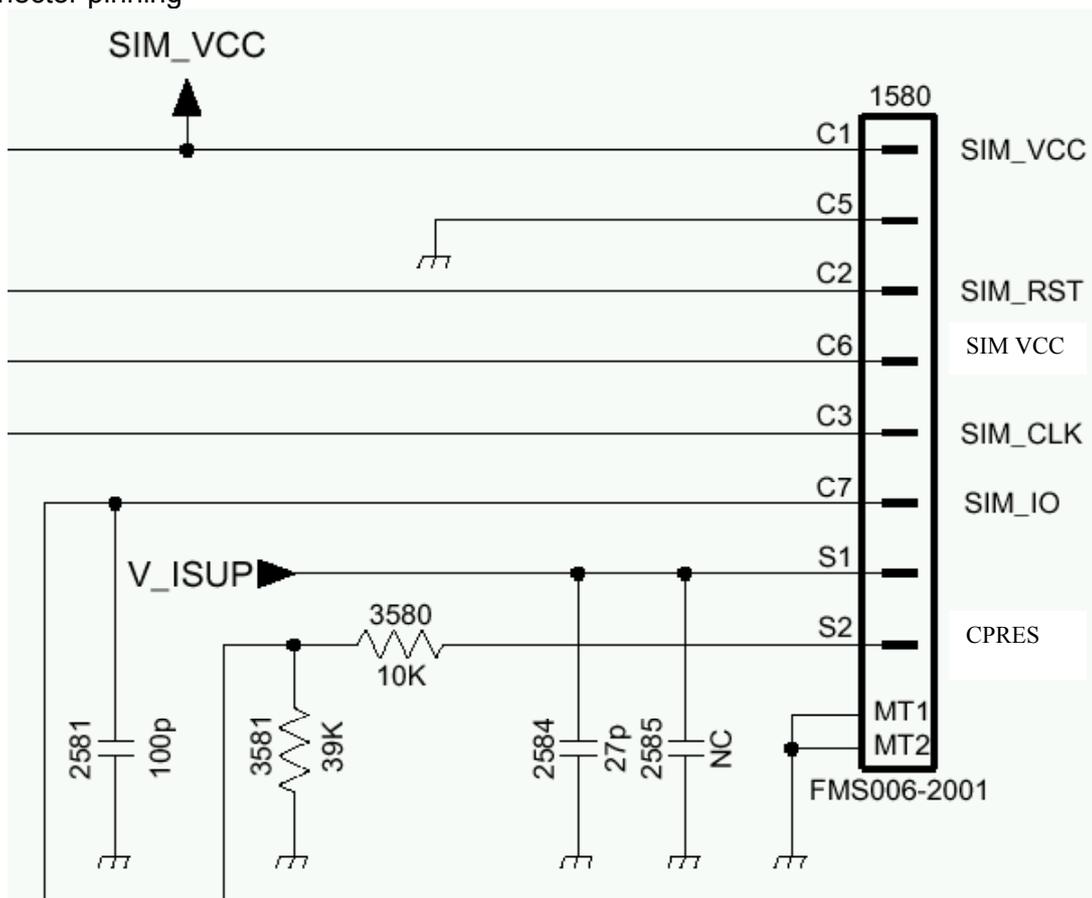
SIM connector pinning

The connector (1580) is connector (8 contacts) used to link with SIM card.

Visually check pins for oxidation or deformity. Visual inspection of the fittings and I/O pads solder joints (short circuit, leak, poor brightness). Measure pins to test points with a multimeter to check for continuity

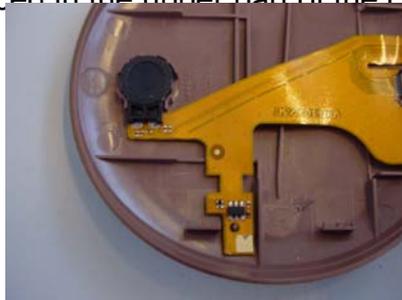
The loudspeaker is placed in the upper part of the clam shell, near display.

Use a hot air nozzle to remove the defective loudspeaker. *Do not apply an excessive heat and flow to avoid destroying the adjoining solder joints.* Level the solder joint on the pads (eventually add solder). Secure new loudspeaker on the flex cable. Reheat the solder on the pads with a fine-tipped soldering iron to allow the solder to flow on the connector's pins.
